No Bleed - No Segregation - No Shrink - No Crack Concrete Tilt Ups

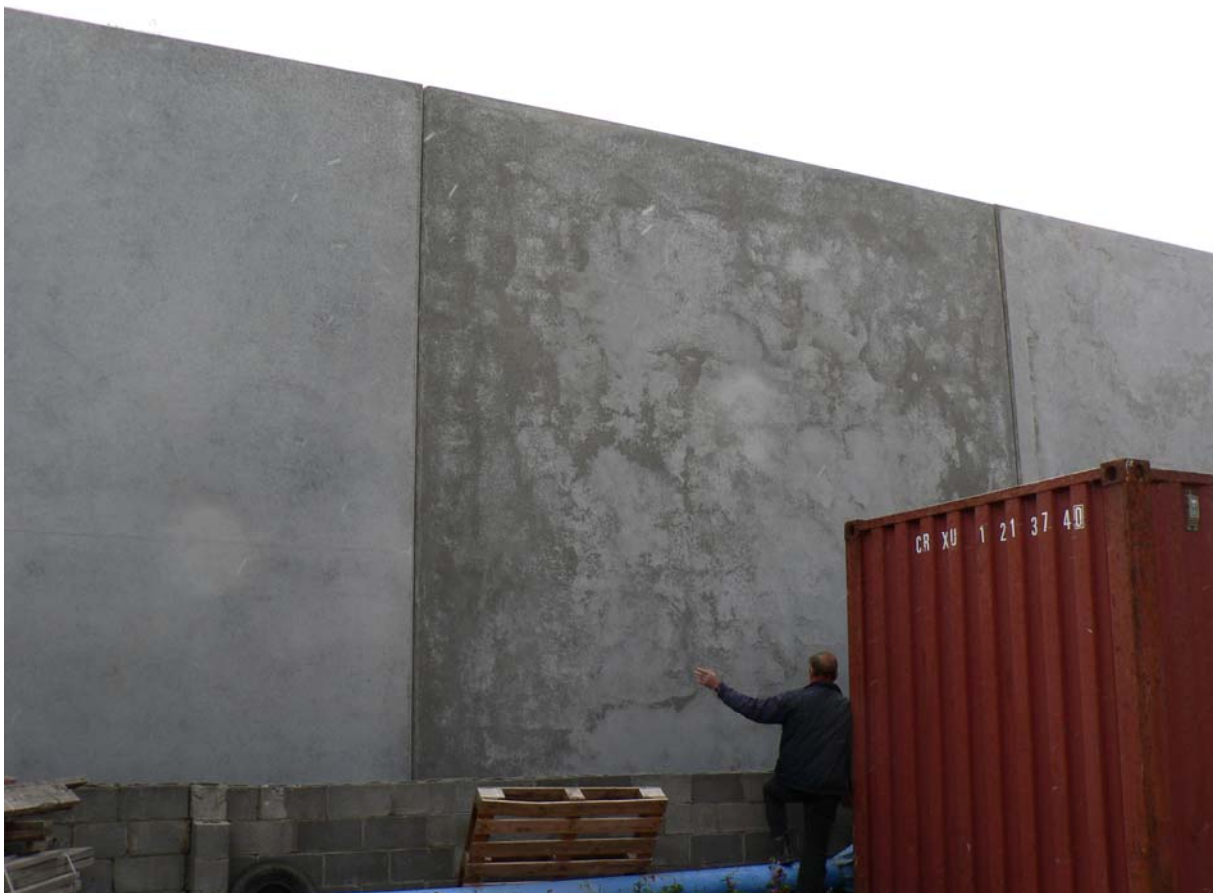
John Higgins Pointing out the Bleed Marks and Segregation on a non Tec-Cement Tilt-Up. Tec-Cement Tilt-Ups Either Side.

The above photo shows TecEco Tec-Cement concrete tilt ups either side of what is an inferior normal concrete from a major supplier. The bleeding and segregation in the centre tilt up using “normal” concrete is obvious.

Our Tec-Cement concrete tilt ups were free of plastic cracking, obvious bleed marking and other defects. Although no samples were taken for strength testing, when hit with a hammer they had a healthy ring about them!
